US Army Corps  
of Engineers®  
Engineer Research and  
Development Center

## **Periodic Inspections of Hilo, Kahului, Laupahoehoe, and Nawiliwili Breakwaters, Hawaii**

Armor Unit Monitoring for Period 2001-2005

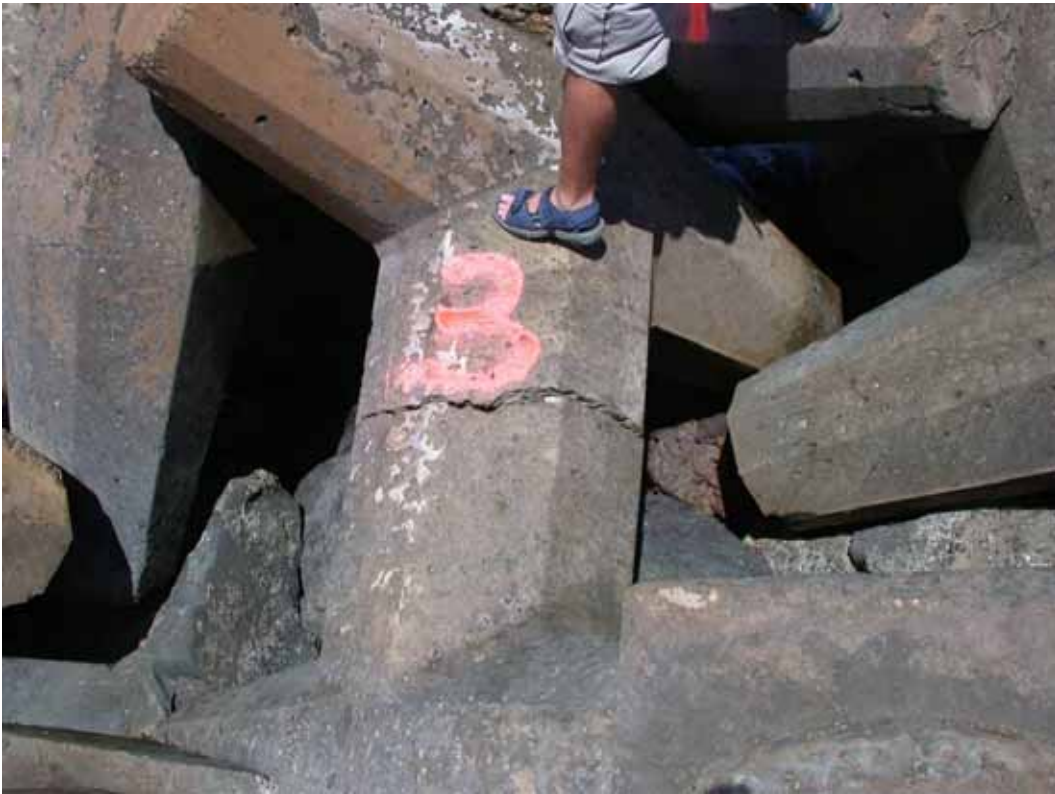
Figure 23. Typical dolosse mid-shank crack/break.

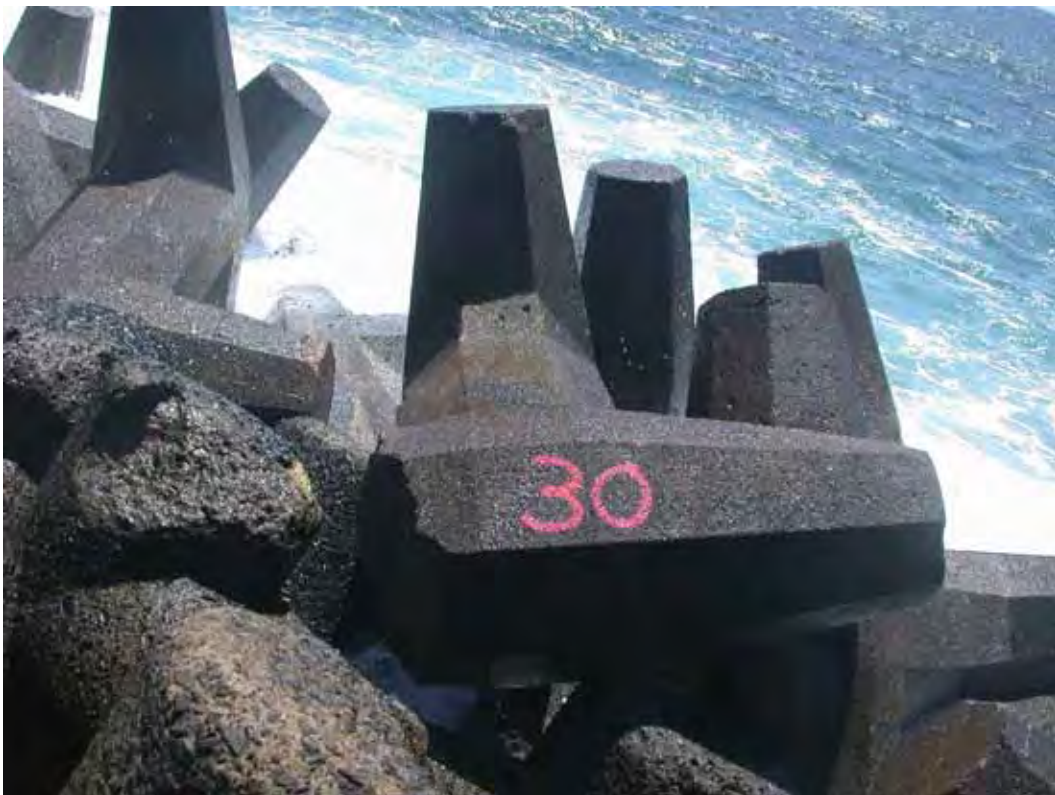
Figure 24. Typical dolosse fluke-shank break.

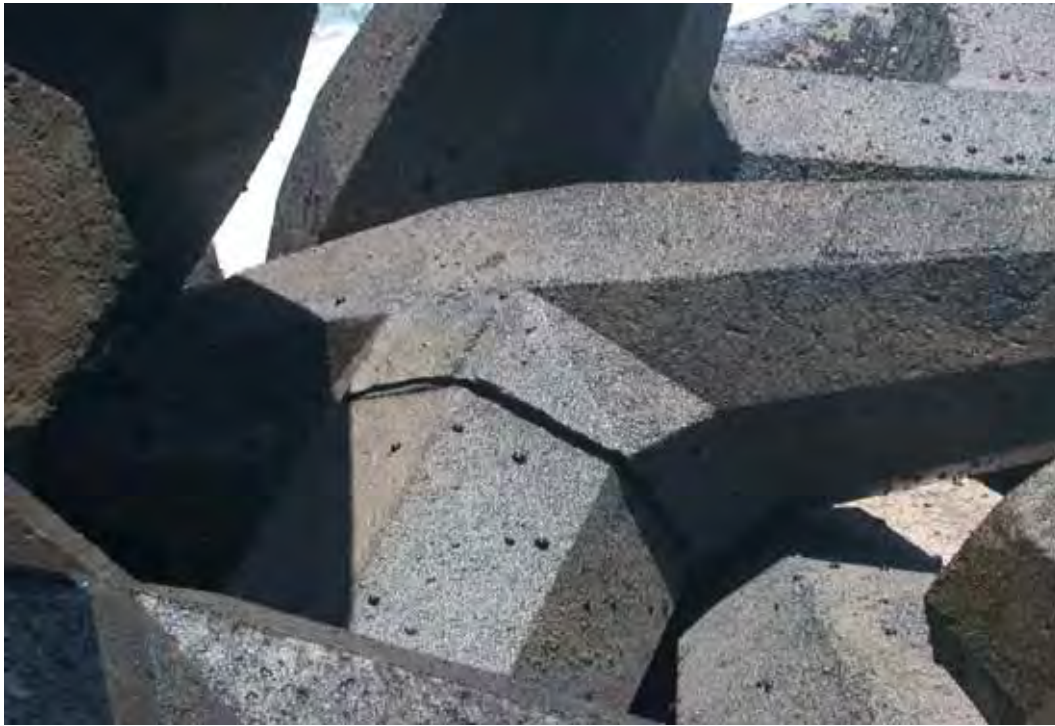
Figure 25. Typical dolosse shank-fluke break.

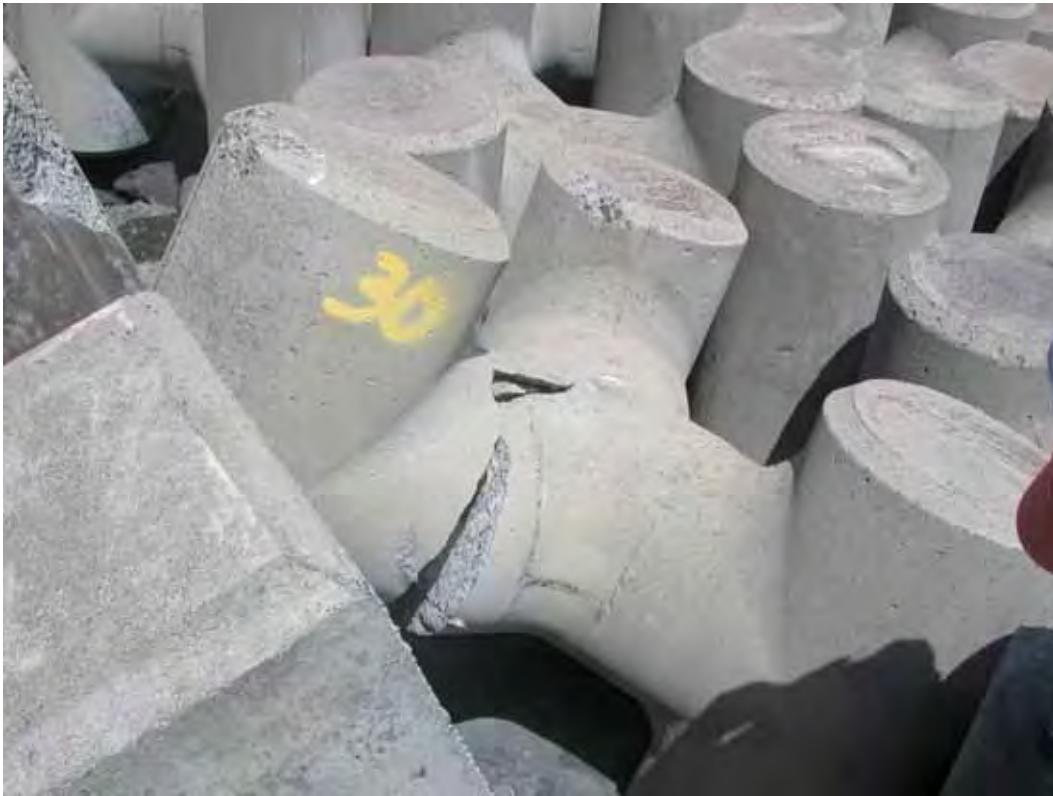
Figure 26. Typical tribar center section break.

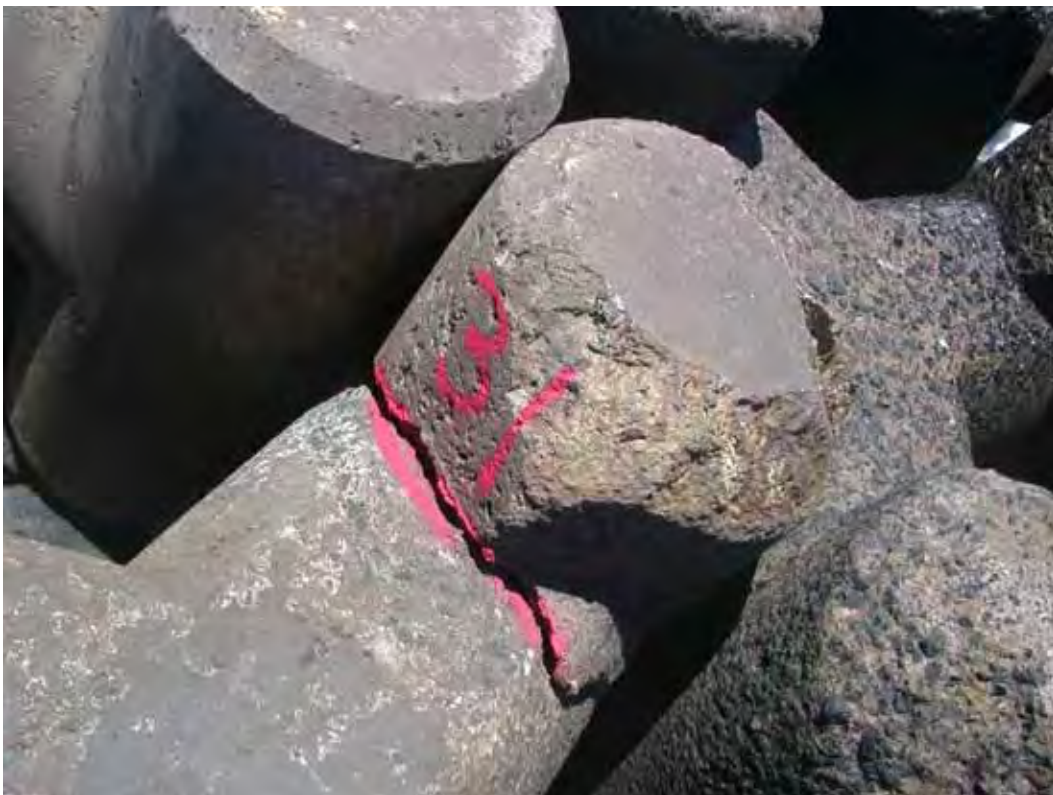
Figure 27. Typical tribar leg break.

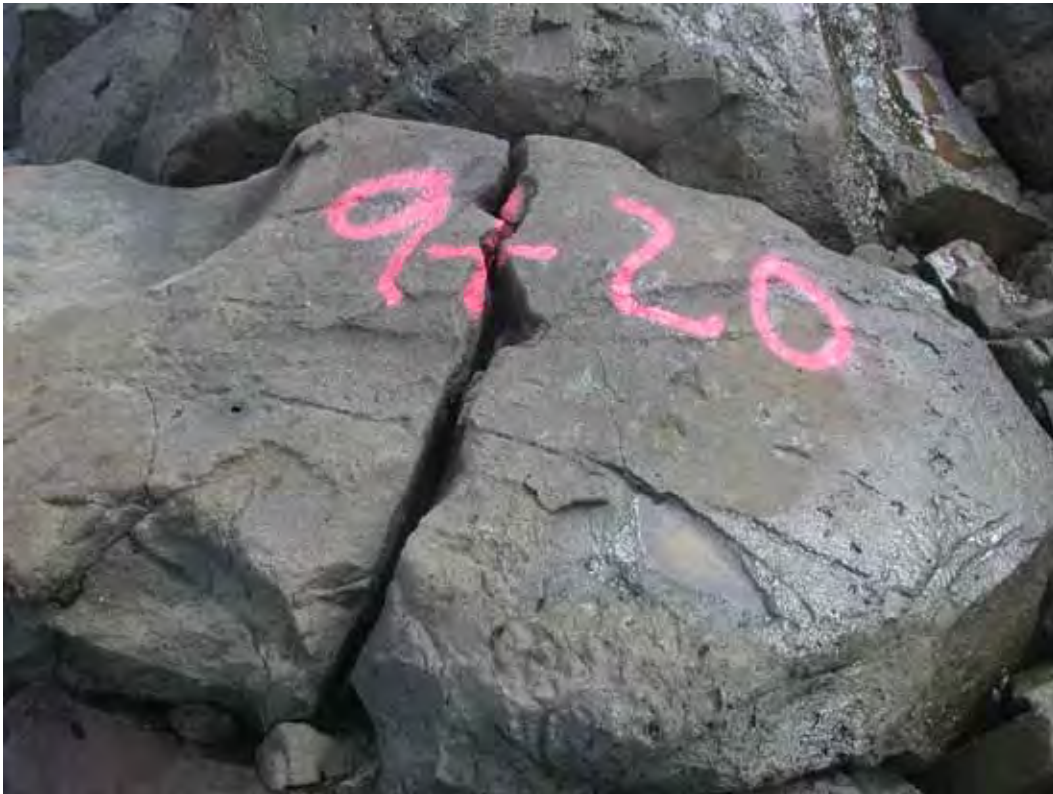
Figure 28. Typical armor stone break.

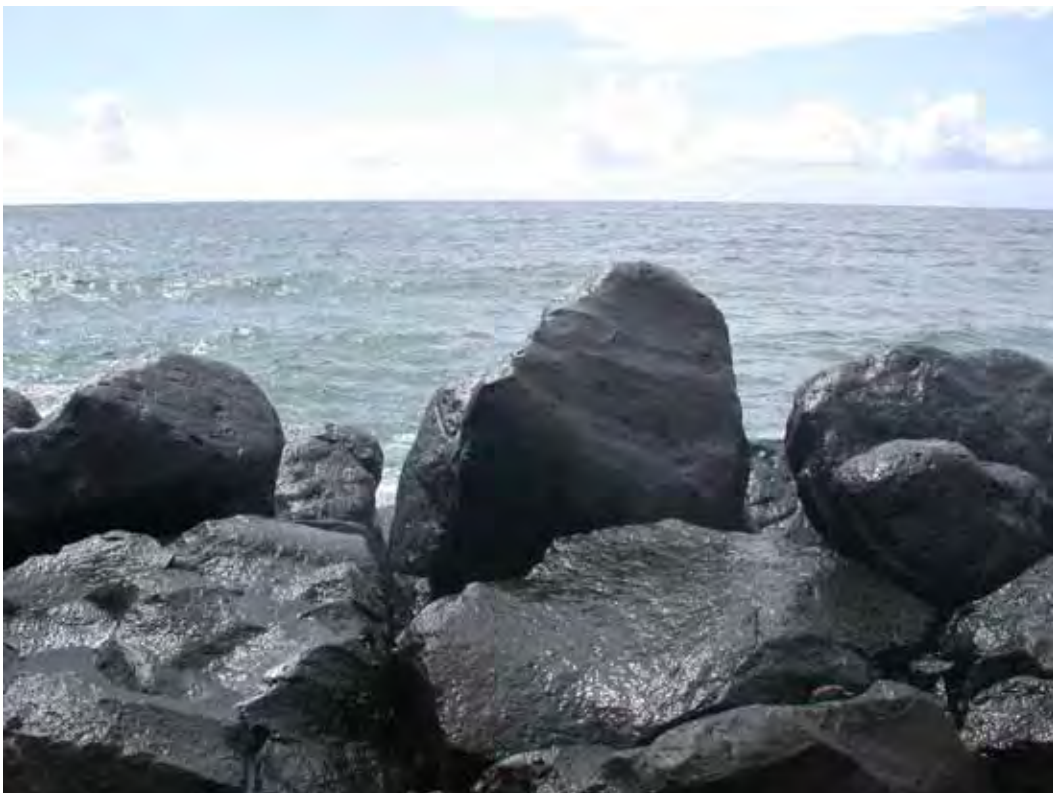
Figure 29. Example of perched armor stones.

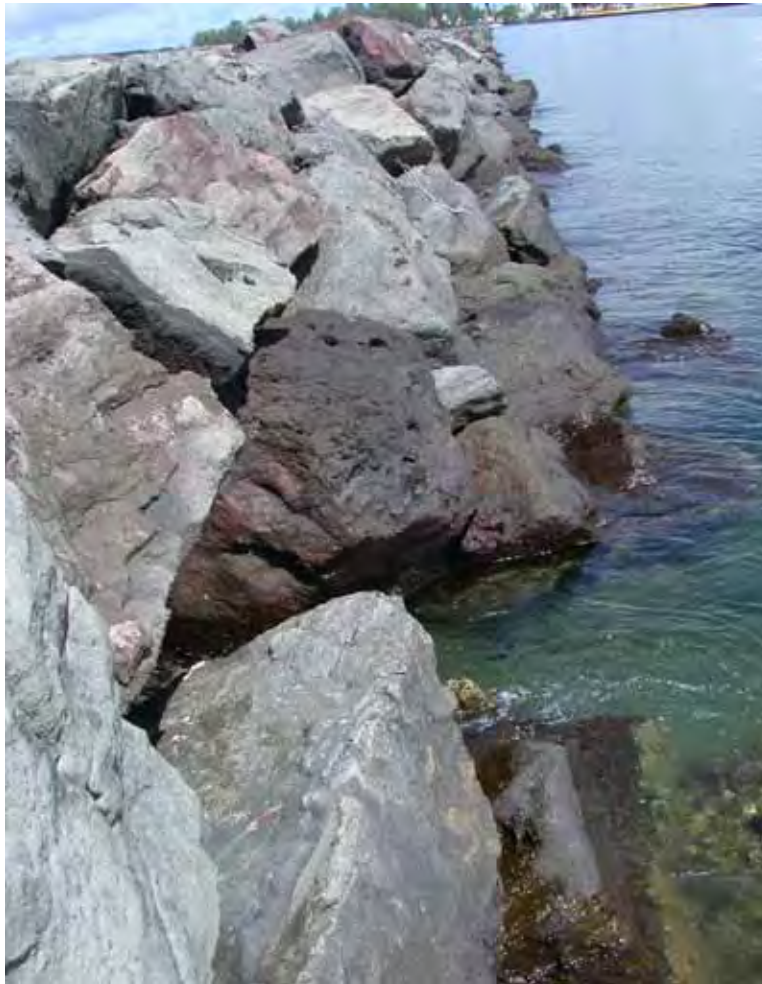
Figure 30. Example of a breakwater void.

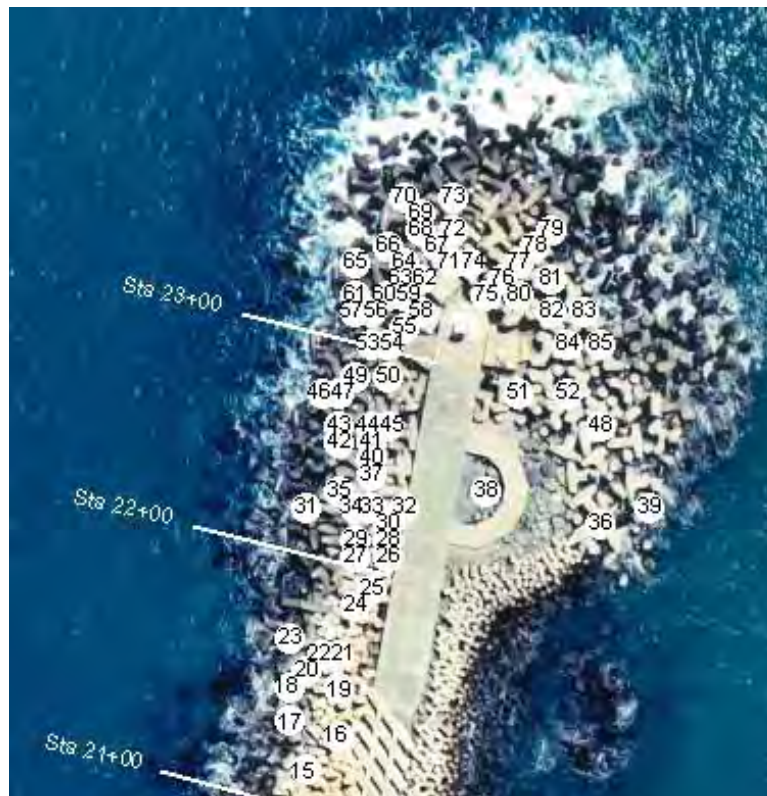
Figure 33. Approximate damage locations on Kahului West Breakwater, photograph 1.

There were 48 broken or cracked dolosse, 26 broken/cracked tribars, and six broken tetrapods on the Kahului West Breakwater. The broken units were concentrated on the ocean side of the structure between sta 21+00 and 23+00, and around the head of the structure (Figures 33 and 34).

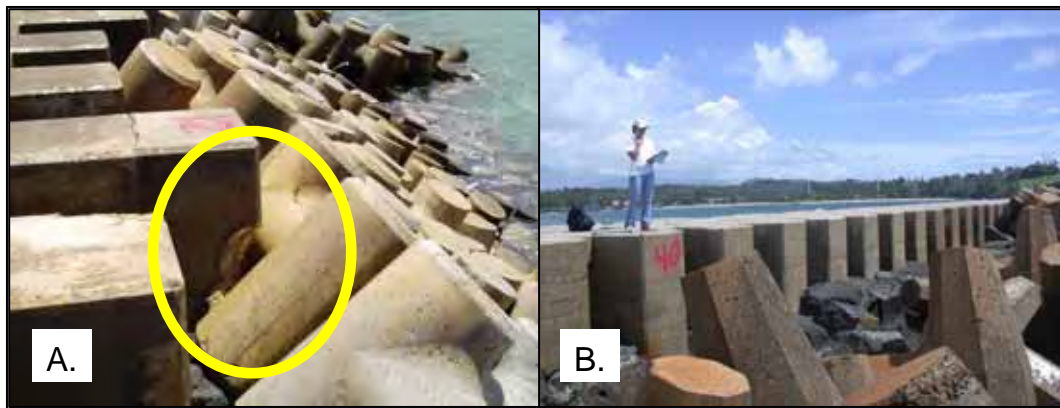
Settling of armor units along the structure has occurred causing a void between the rib cap and armor units (Figure 38a and b). The circle on Figure 38a indicates an example of a void created as the result of tribar detaching from the rib cap. The side slope subsidence of dolosse is shown in Figure 38b.

Figure 38. Evidence of armor stone subsidence.

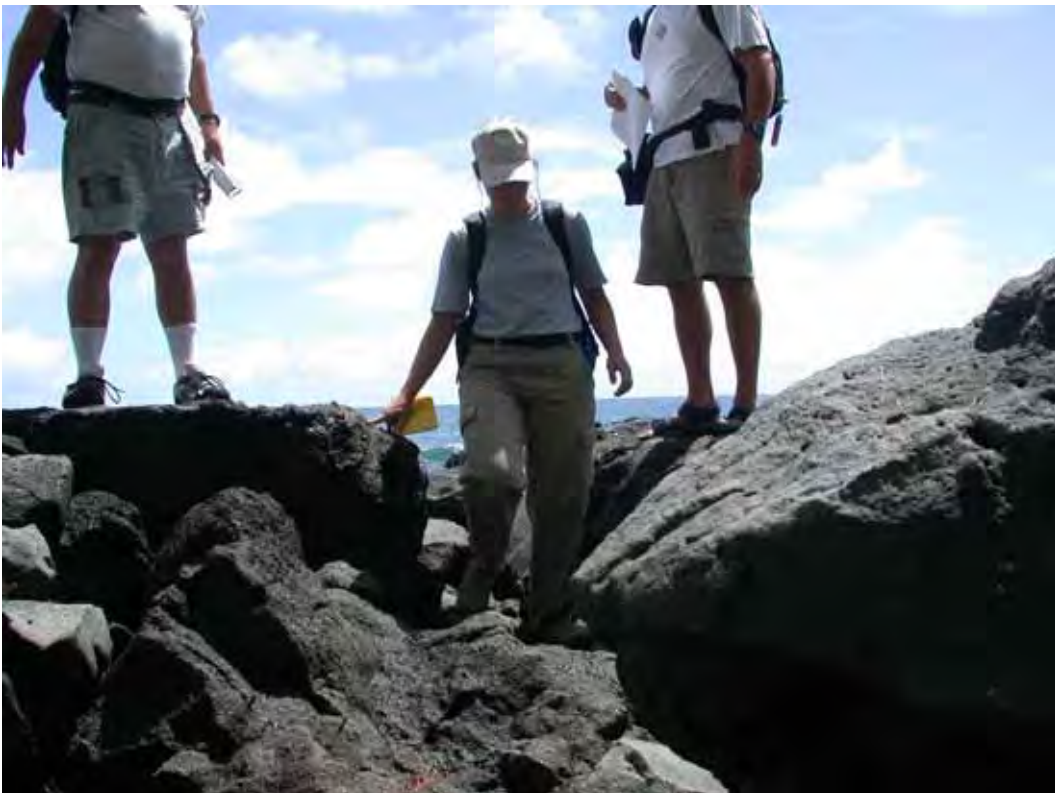
Figure A2. Damage location 1, sta 2+60, harbor side, missing armor stone, 8-ft x 4-ft void.

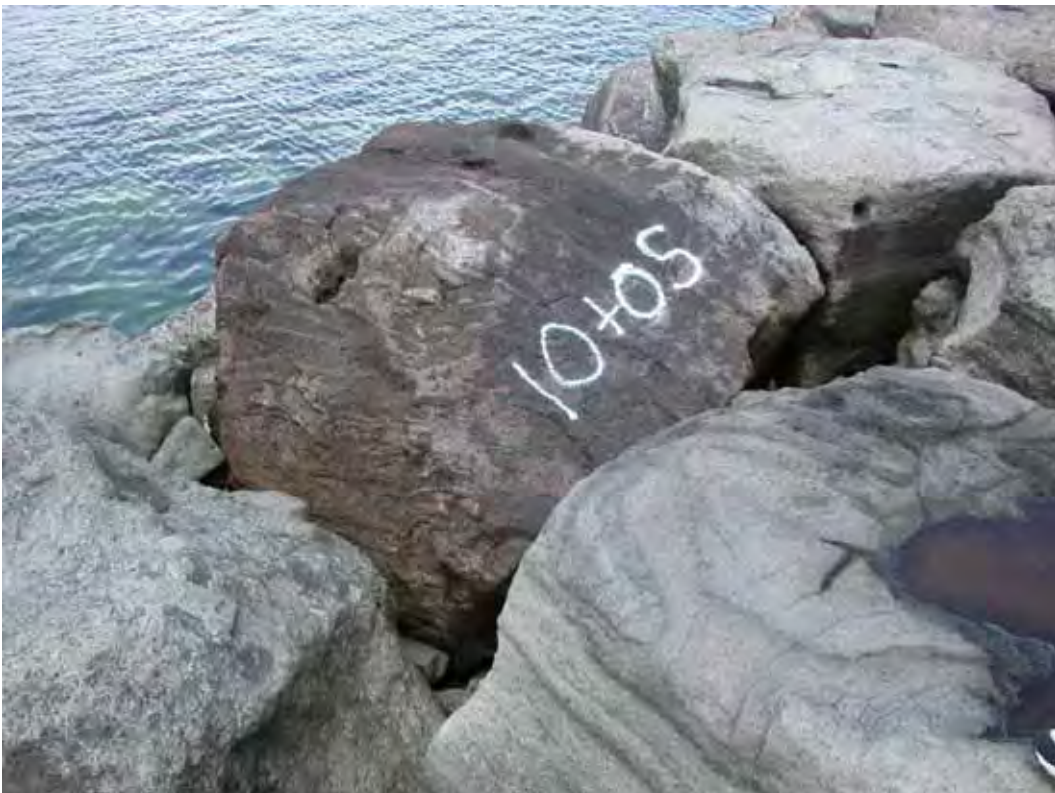
Figure A6. Damage location 5, sta 10+05, harbor side, void.

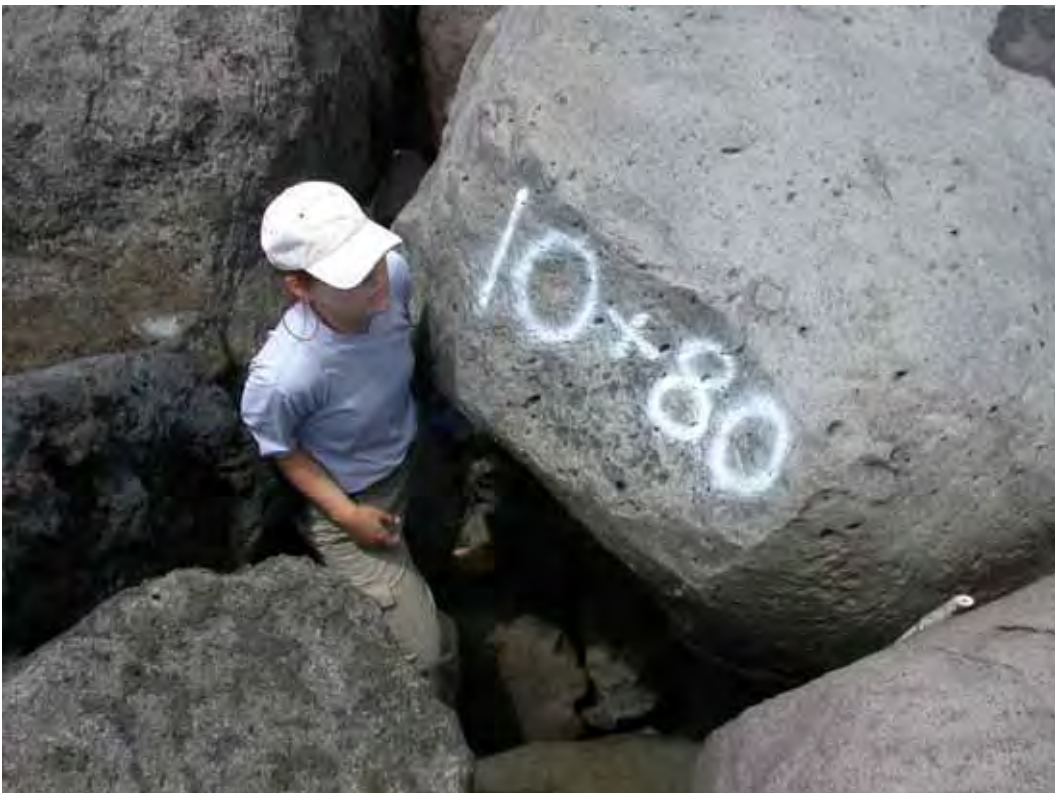
Figure A8. Damage location 7, sta 10+80, harbor side, void approximately 5 ft deep.

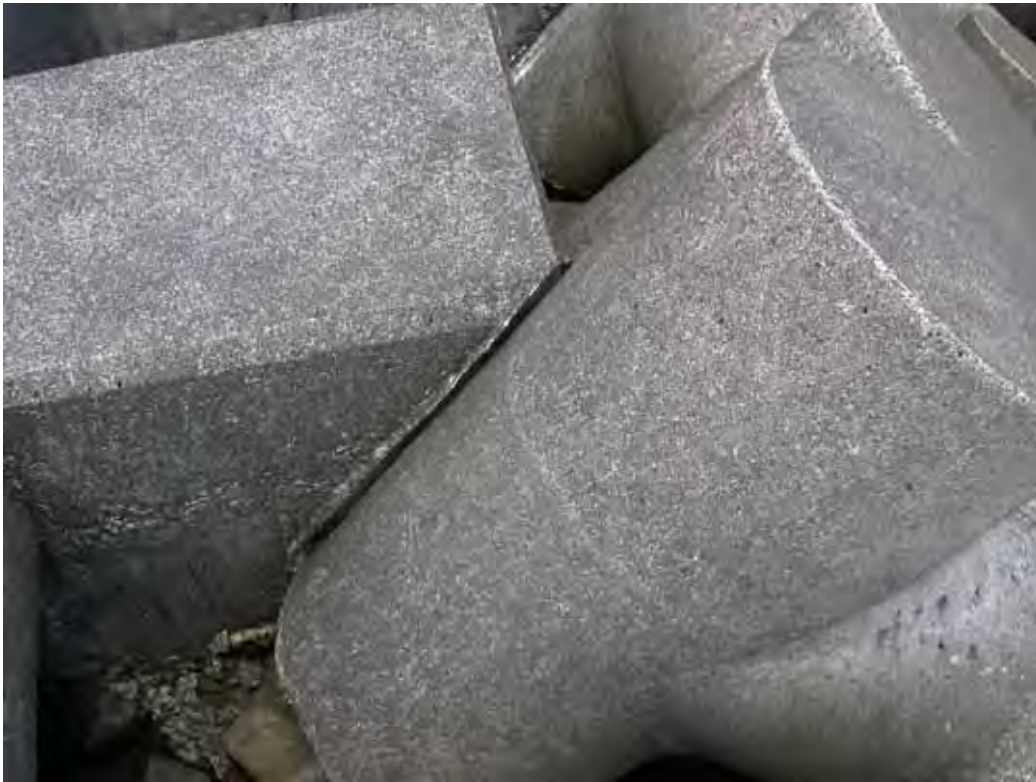
Figure A9. Damage location 8, sta 11+18, tribars separating from rib cap, side slope steepening.

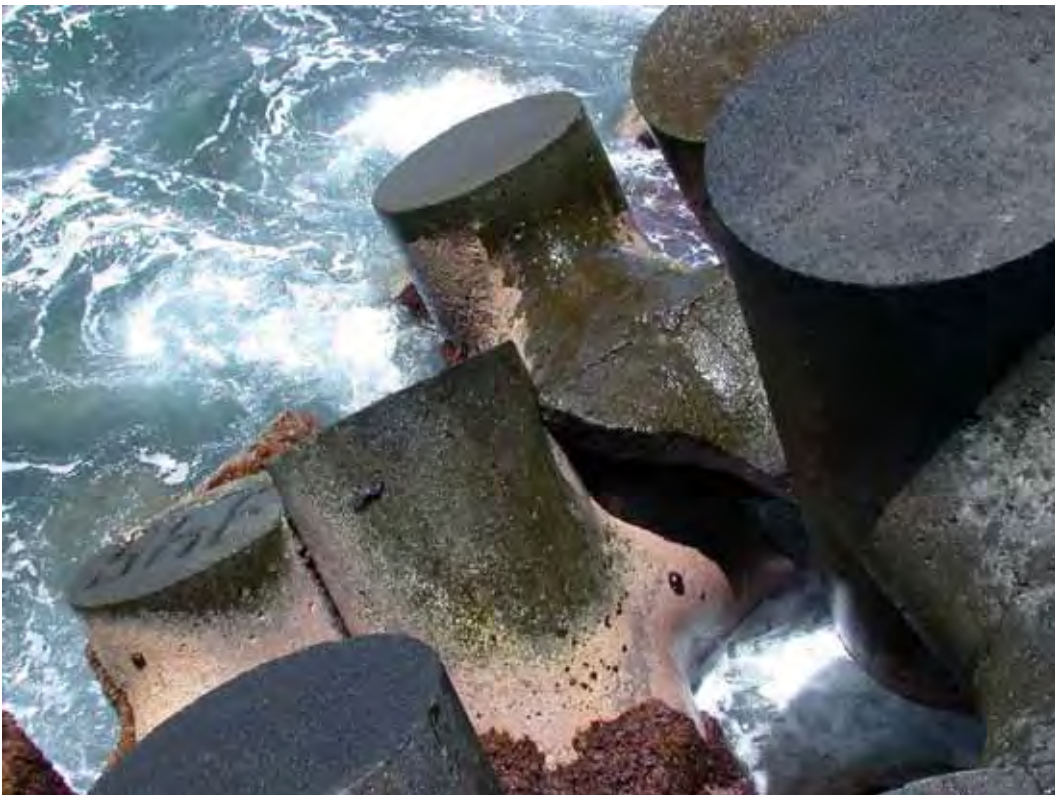
Figure A16. Damage location 16, sta 17+40, ocean side, broken tribar at waterline.

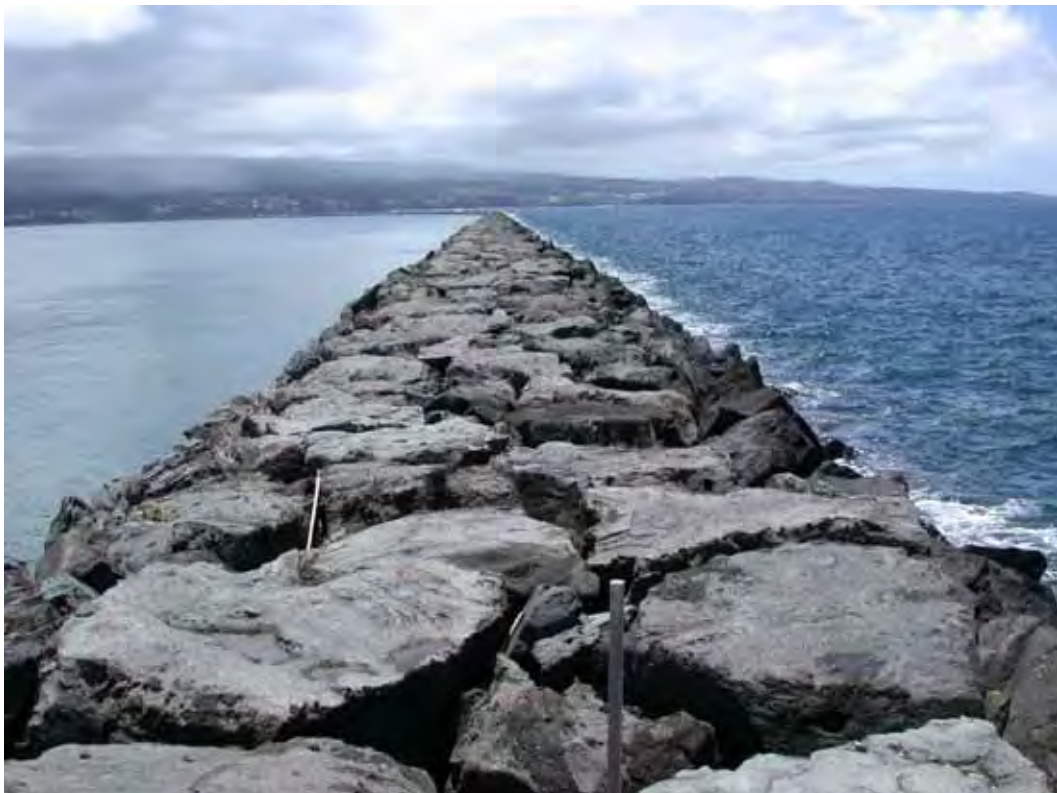
Figure A18. Sta 19+90, end of rib cap, overview looking north.

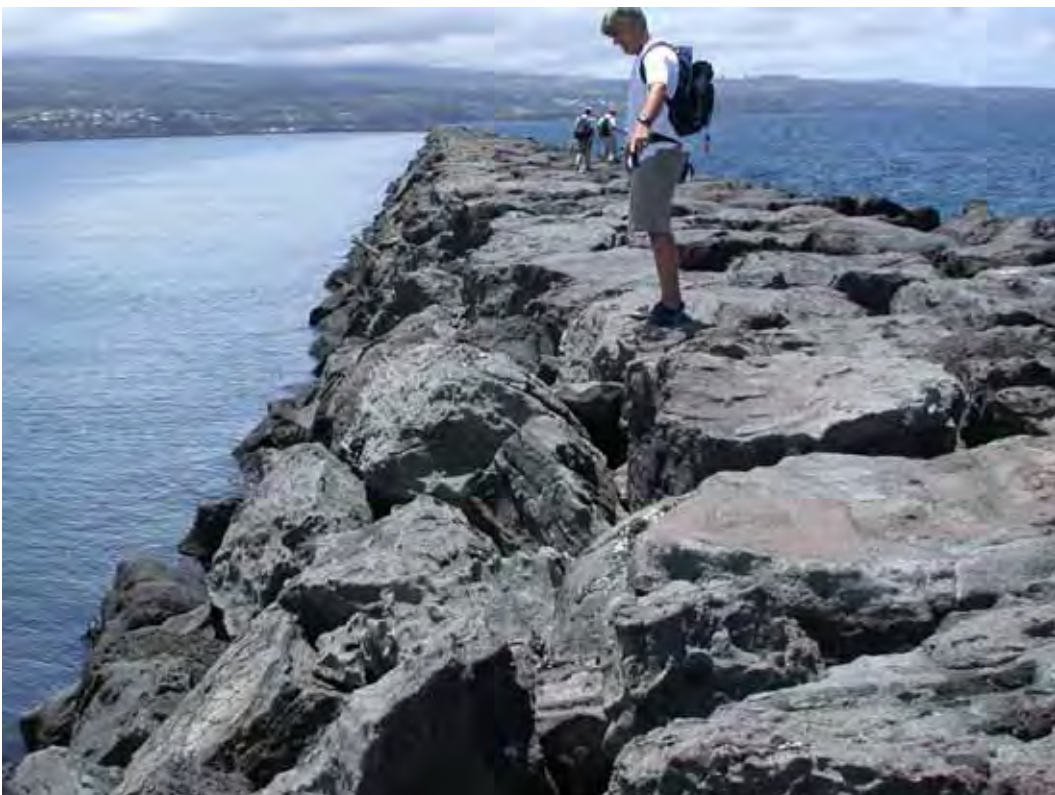
Figure A20. Damage location 19, sta 22+10, harbor side, sloped crest.

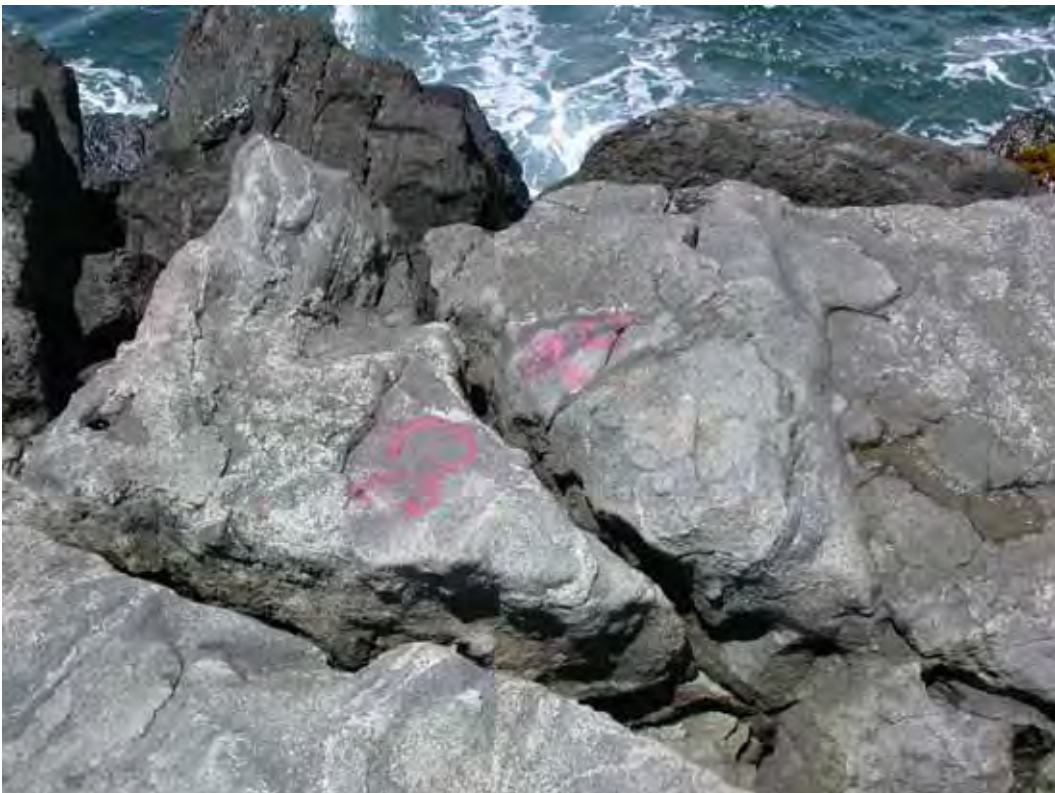
Figure A22. Damage location 21, sta 22+90, ocean side, cracked armor stone.

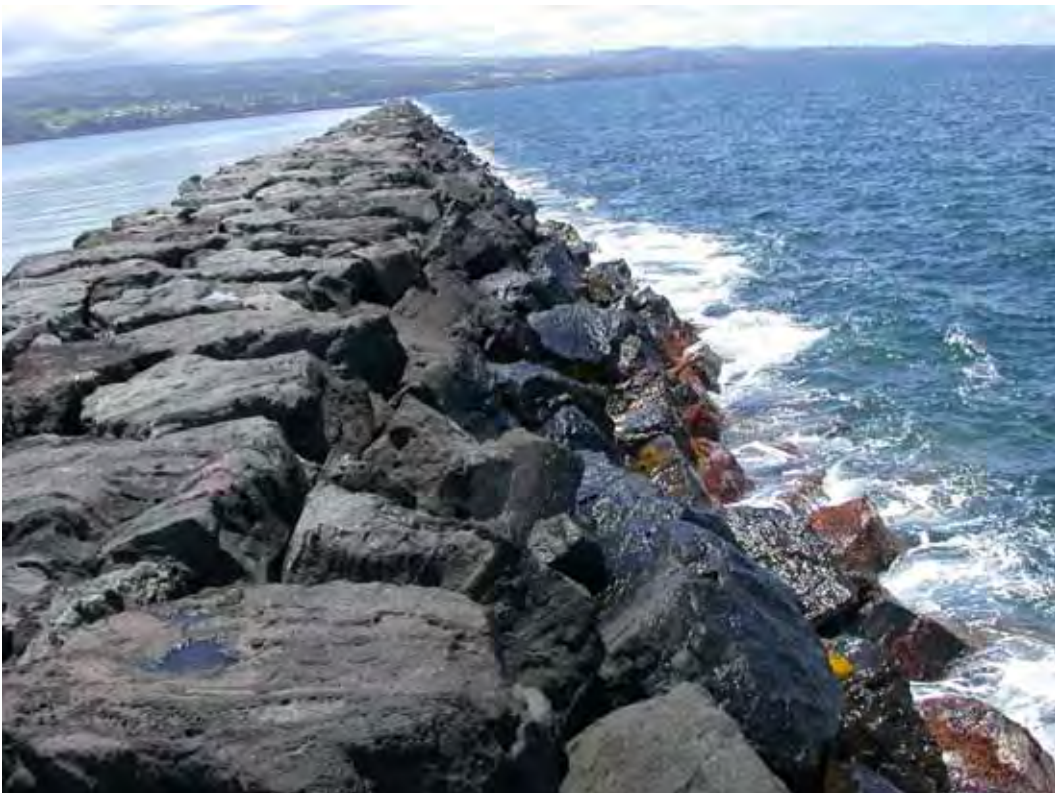
Figure A24. Damage location 23, sta 23+90-24+15, ocean side, void and settling.

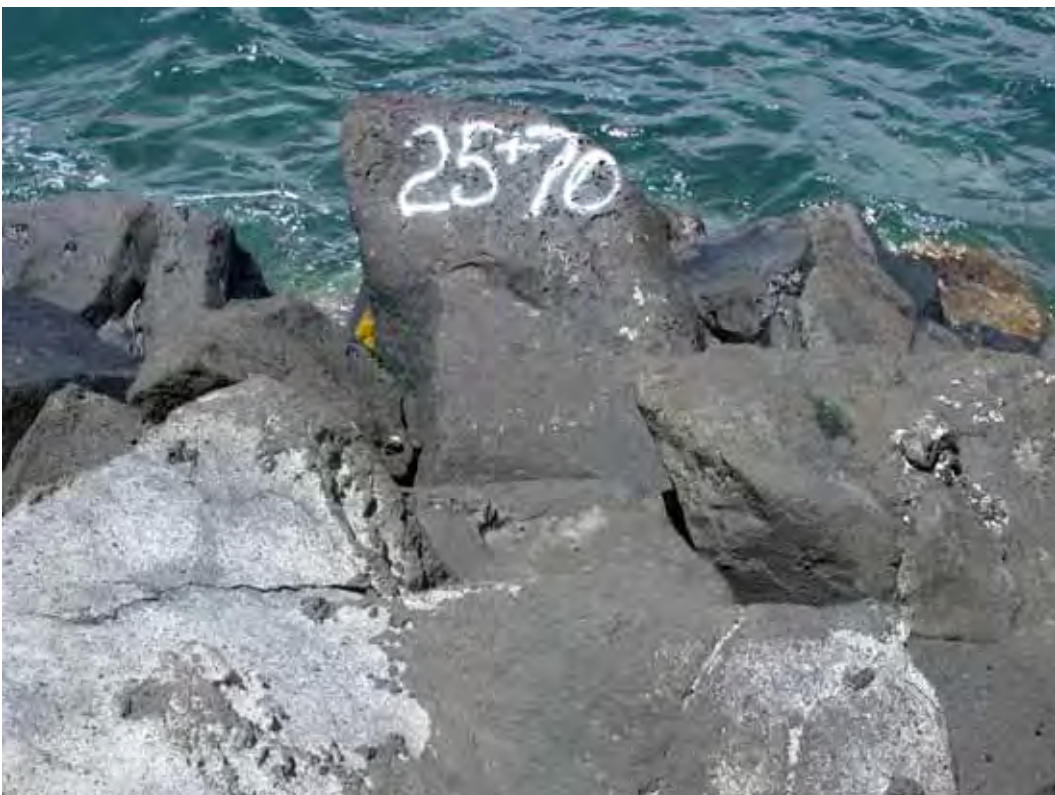
Figure A27. Damage location 26, sta 25+70, ocean side, dislodged stone.

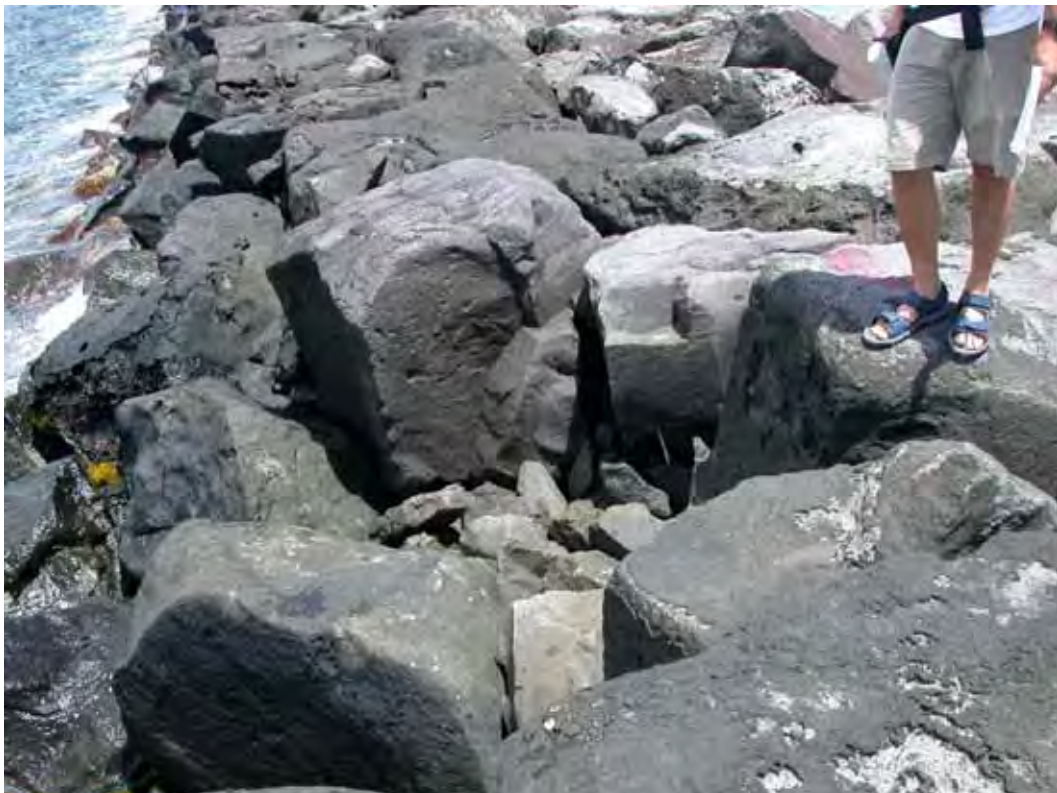
Figure A31. Damage location 31, sta 28+78, missing crest stone.

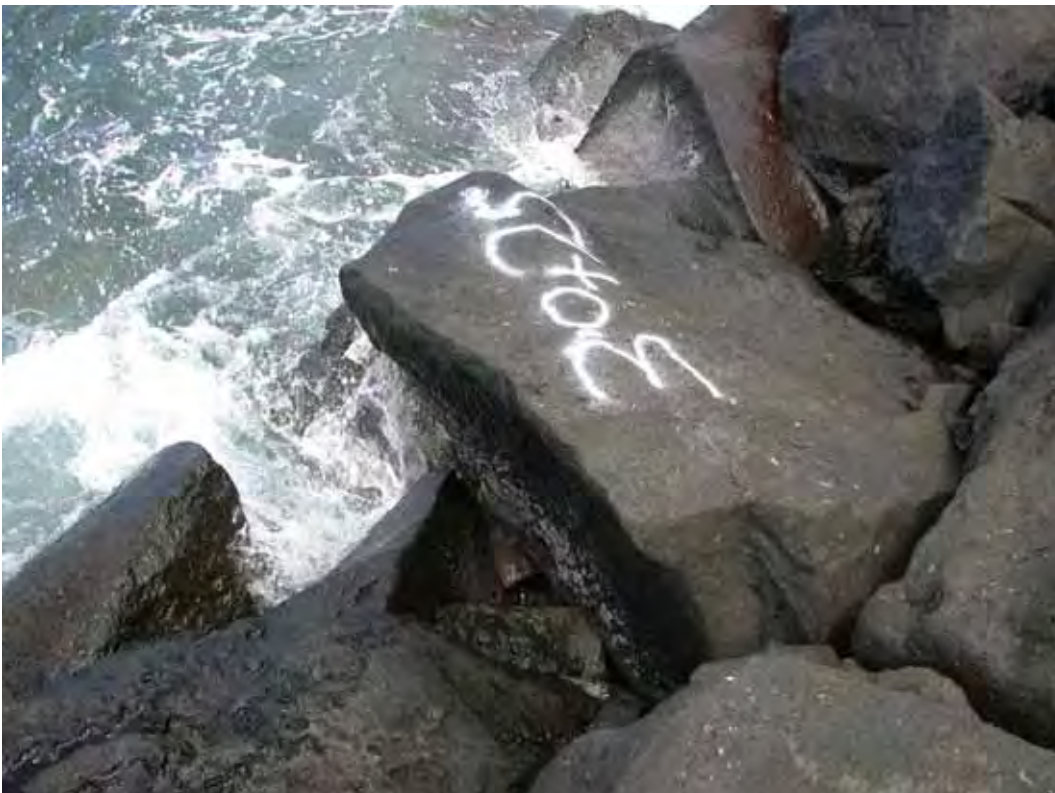
Figure A33. Damage location 35, sta 30+25, ocean side, overhanging hinge stone.

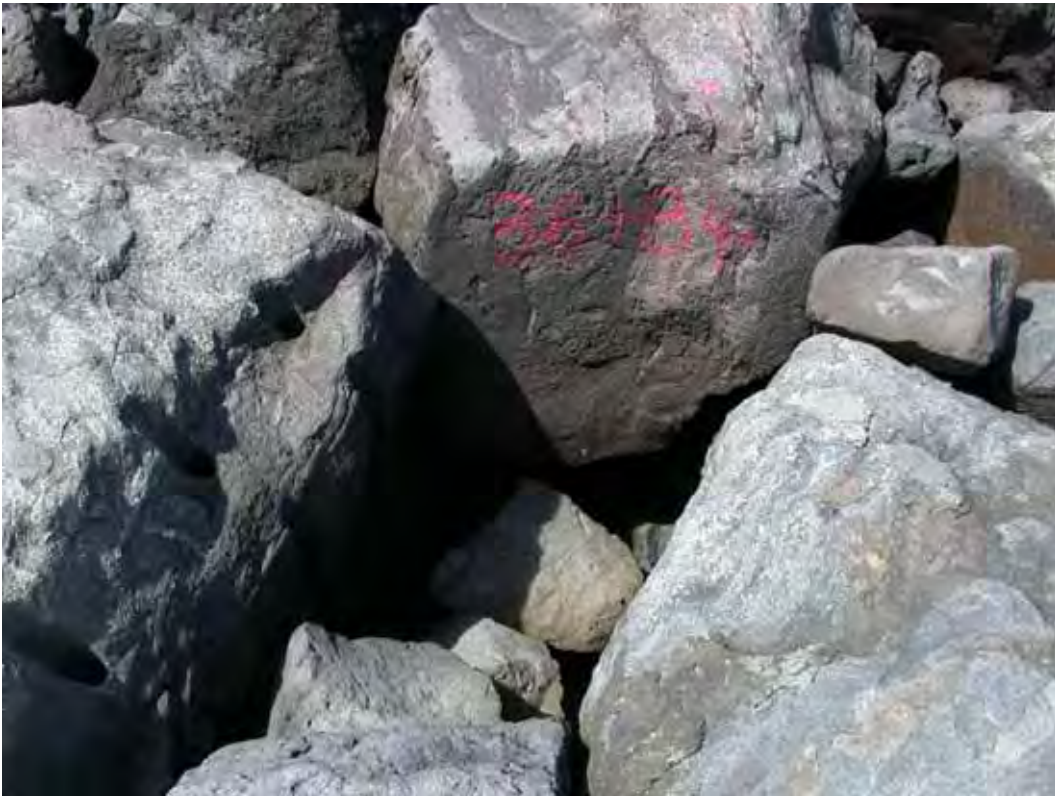
Figure A38. Damage location 40, sta 35+84, void at crest.

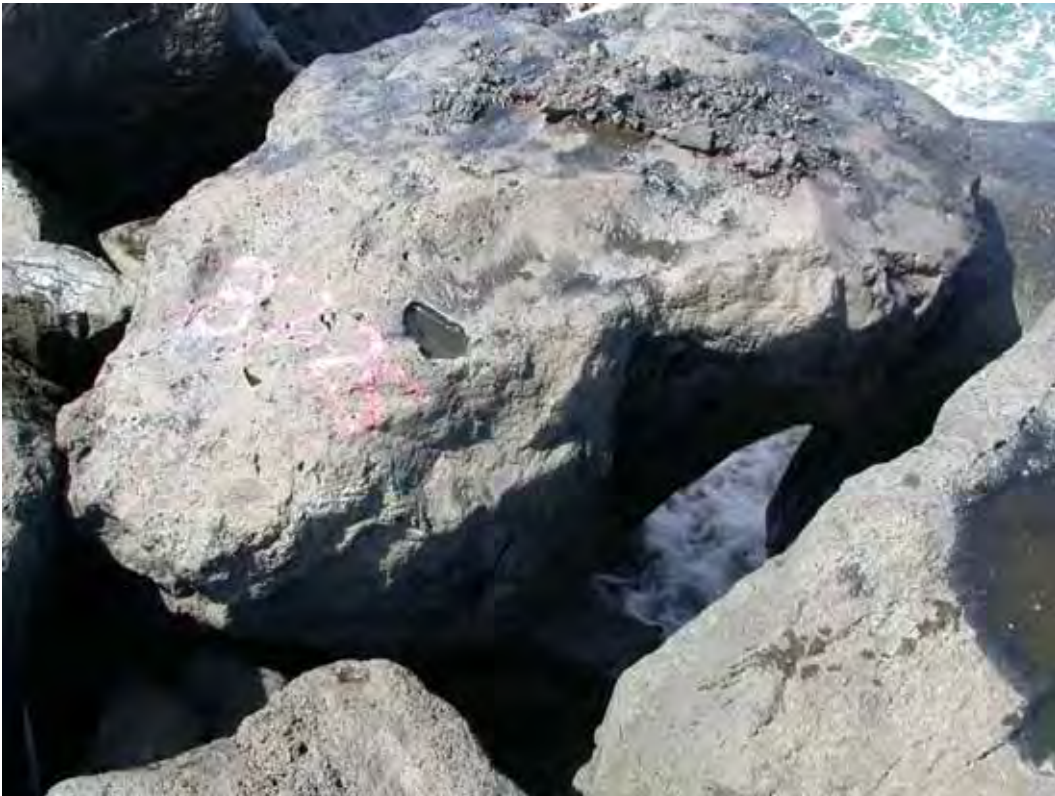
Figure A41. Damage location 43, sta 37+25, ocean side, bridging at crest.

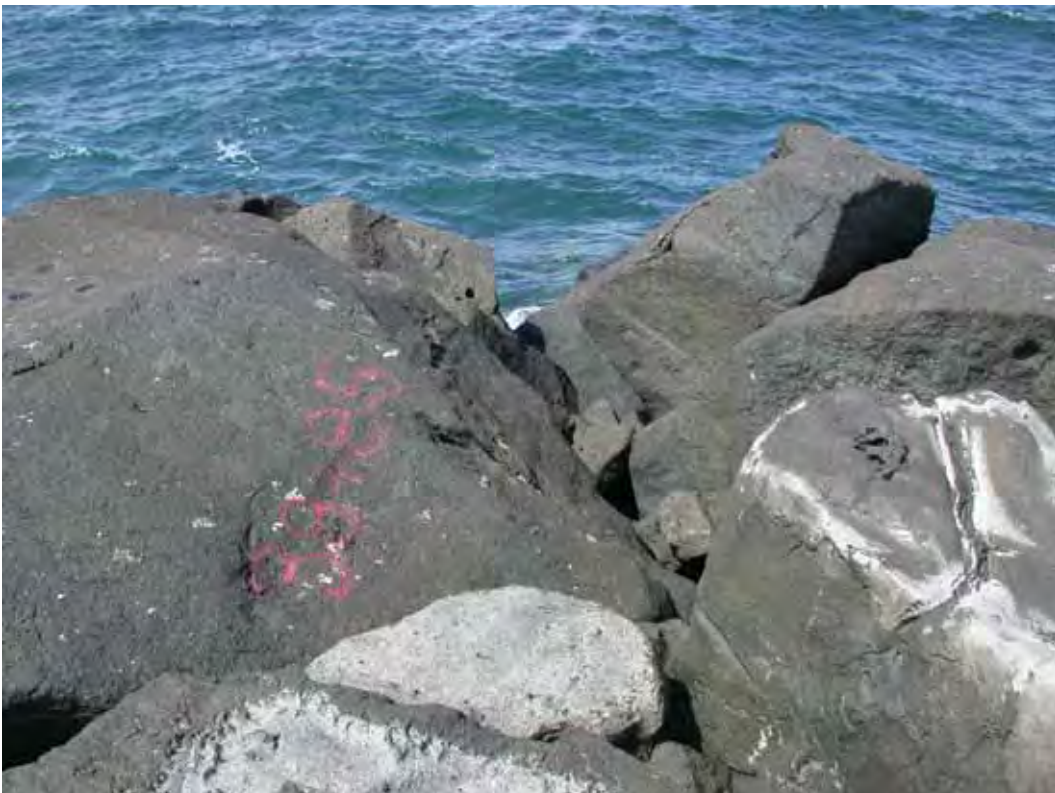
Figure A42. Damage location 44, sta 38+85, two perched armor stones.

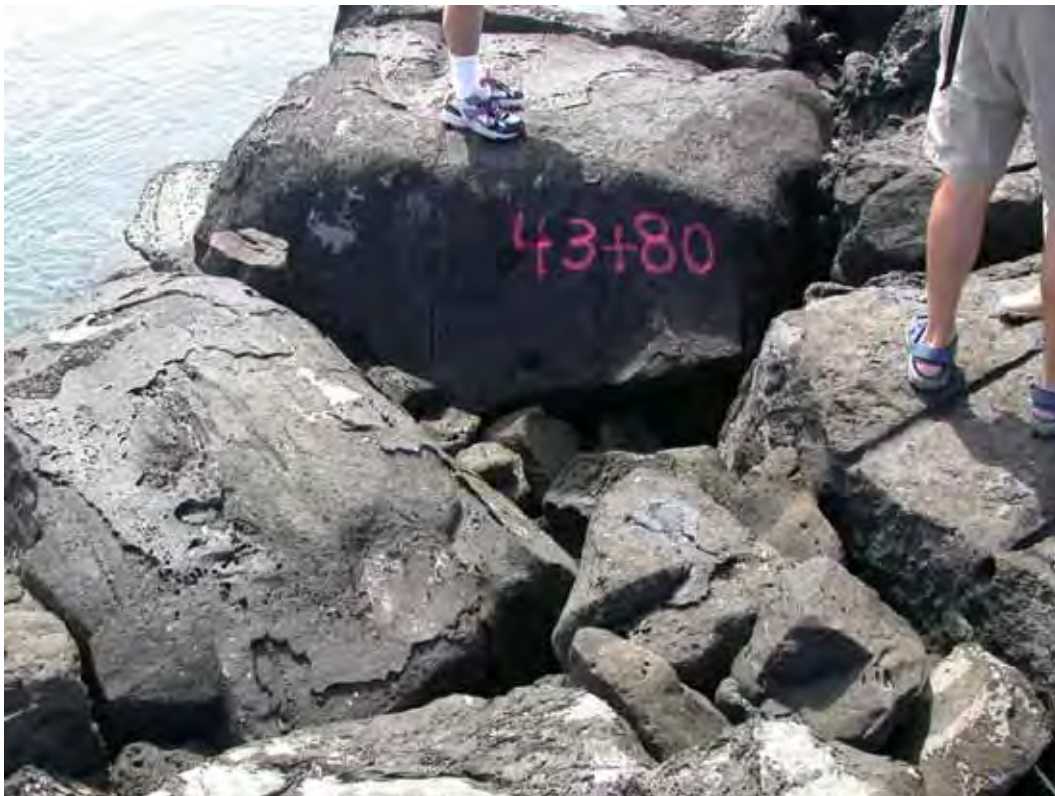
Figure A44. Damage location 46, sta 43+80, harbor side, void at crest (4 ft x 3 ft x 4 ft).

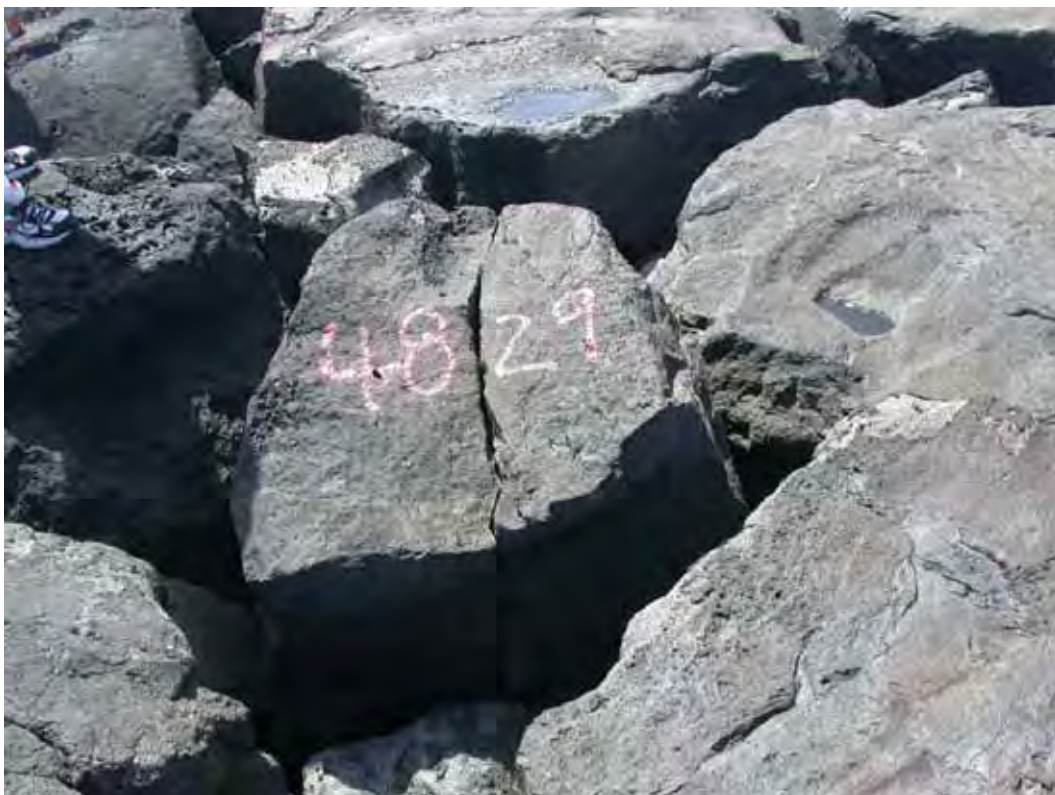
Figure A45. Damage location 48, sta 48+29, broken stone on crest.

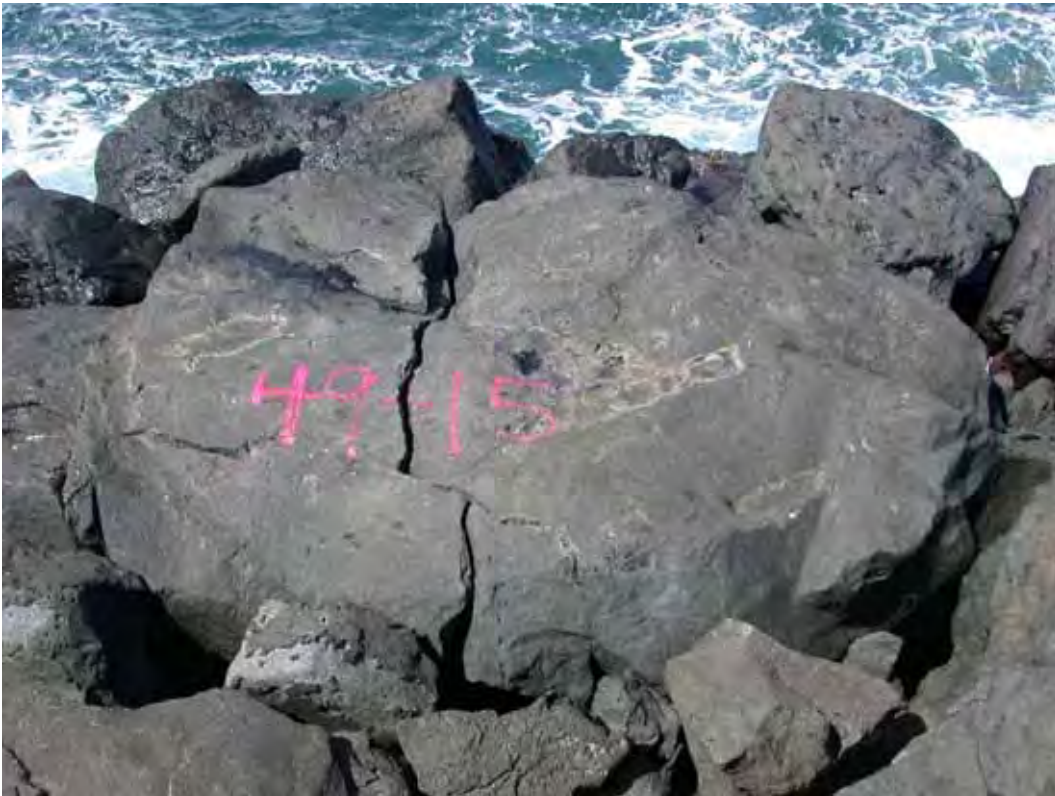
Figure A46. Damage location 49, sta 49+15, ocean side, broken stone on crest.
